SAMPLE BUILDING - Any City, State

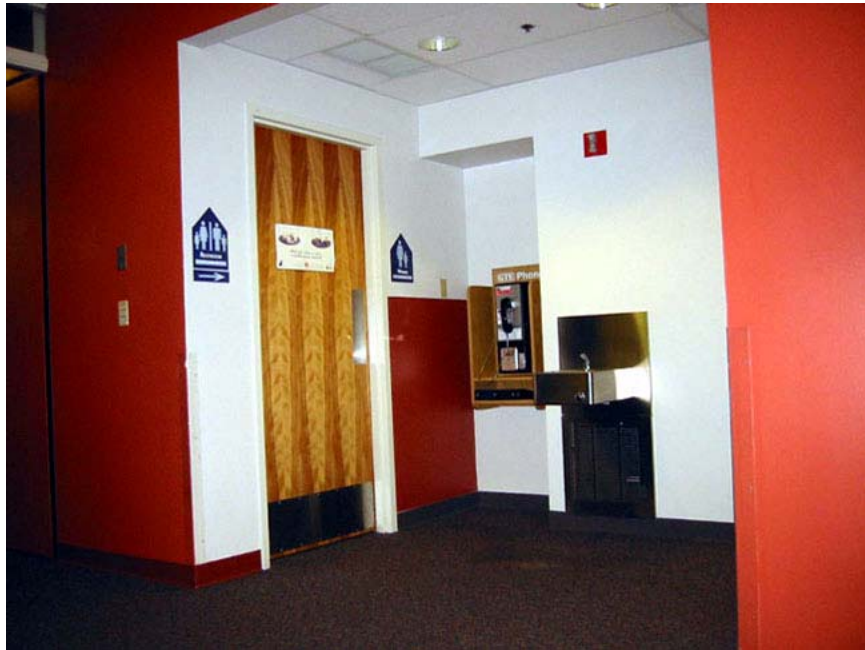
Upper Left: Women's Public Restroom Entry area. The telephone (located in the alcove) lacks maneuvering space. The signage (at Women's Public and Men's Public Restrooms) is mounted higher than 60" (measured at centerline of sign).

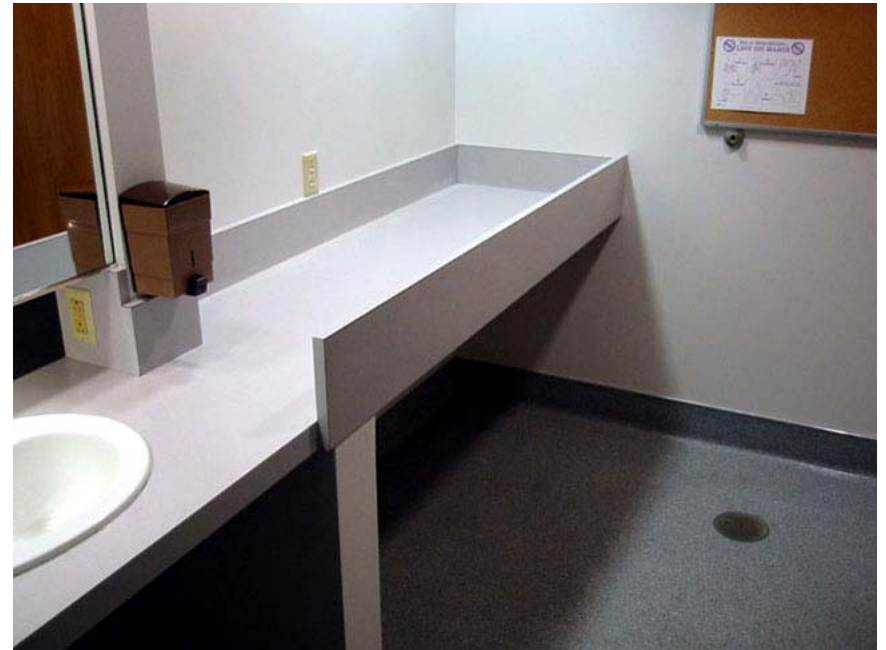
Upper Right: Men's Public Restroom. The security panel (at the Baby Changing area) encroaches on door maneuvering space (required depth) at entry door. The top of security panel is too high to be accessible (measured at 39" AFF).

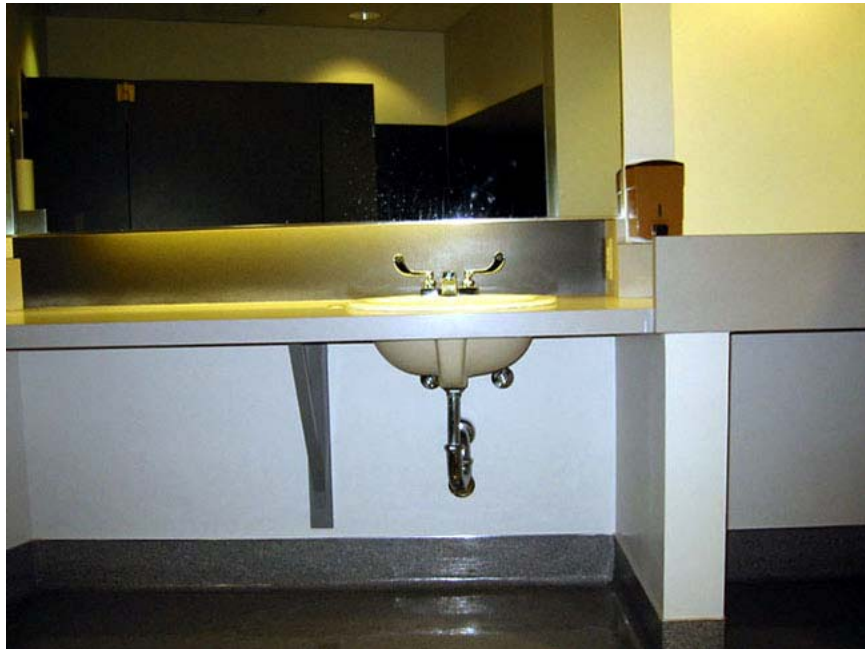
Lower Left: Men's Public Restroom. The bottom edge of the mirror is mounted higher than 40" maximum. The sink lacks pipe wrapping (Typical).
